### **36. Site 36 at RM 217.5 RDB (Pool 26)**

### **36a. Observation Site at RM 200.2 RDB (Pool 27)**

### ***37. Site 37 at RM 197.6 RDB (Pool 27)***

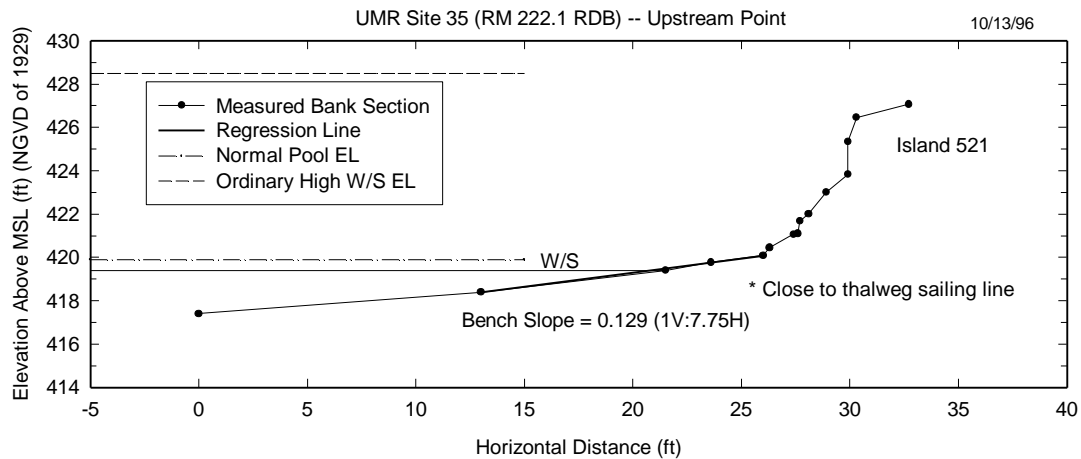
**Figure 7-115 Bank section measured at Site 35 upstream point**

from the confluence of the Illinois River. Photo 7-85 shows an upstream view of this site, and Photo 7-86 shows exposed tree roots. Three bank sections taken are shown in figures 7-115 through 7-117. The bank soils are fine silt (FST) to coarse clay (CC).

Causative factors for bank retreat at this site include flood-flow erosion and rapid recessional slumping, minor piping and collapse, and wave and rework-transport of failed soils and recently deposited sediments within bench areas. Because the site is very close to the thalweg sailing line, wave erosion within bench areas is more significant. Site 35 can be classified as Type A.

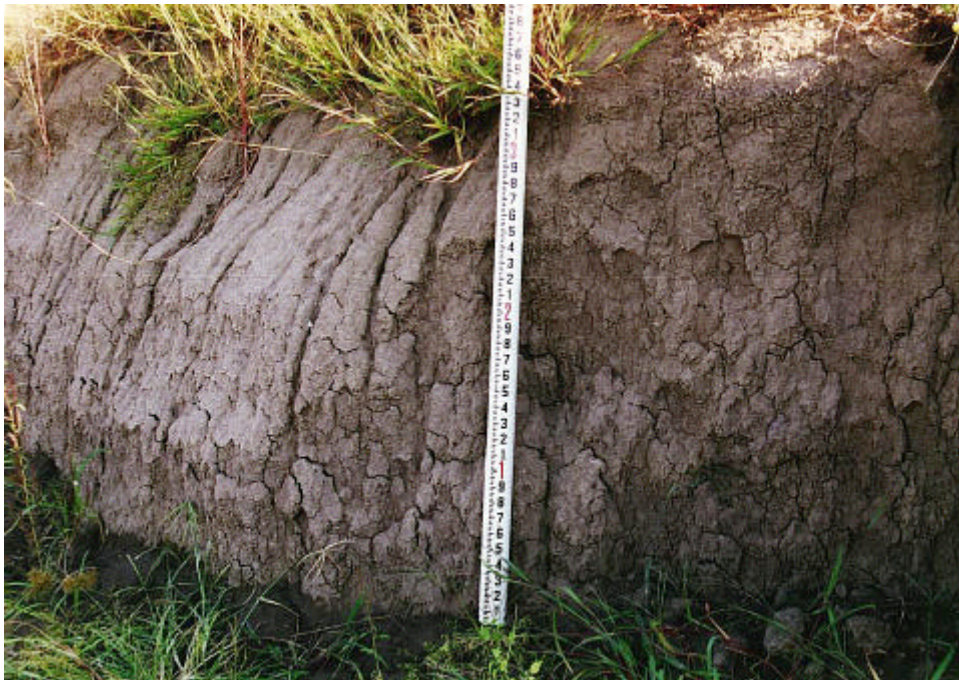
This right-bank site, shown in figure 7-118, is located along a rather straight reach, just 0.5 mile downstream from the confluence of the Illinois River, 14.6 miles upstream from Lock & Dam No. 26. Photo 7-87 shows a downstream view of the site, and Photo 7-88 shows a close-up view of the scarp. The bank section taken is shown in figure 7-119. The river cross section indicates that the site is located in the convex bank of a minor bend. At the top of the bank is a farm field, and some segments of a local road were found to be collapsing due to bank retreat. The bank soils consist of fine to medium silt (FST-MST) and fine sand (FS). Subaqueous sediments are fine sand (FS).

**Photo 7-88 A close-up view of scarp of Site 36 midpoint**

Causative factors for bank retreat at this site include flood-flow erosion and recessional block failures, piping and collapse, slaking, overland drainage, and wave and seepage rework and transport of failed and slaked soils and recently deposited sediments within bench areas. Because the thalweg sailing line is far from the site, traffic-generated wave erosion appear to be minor. Type C can best describe Site 36.

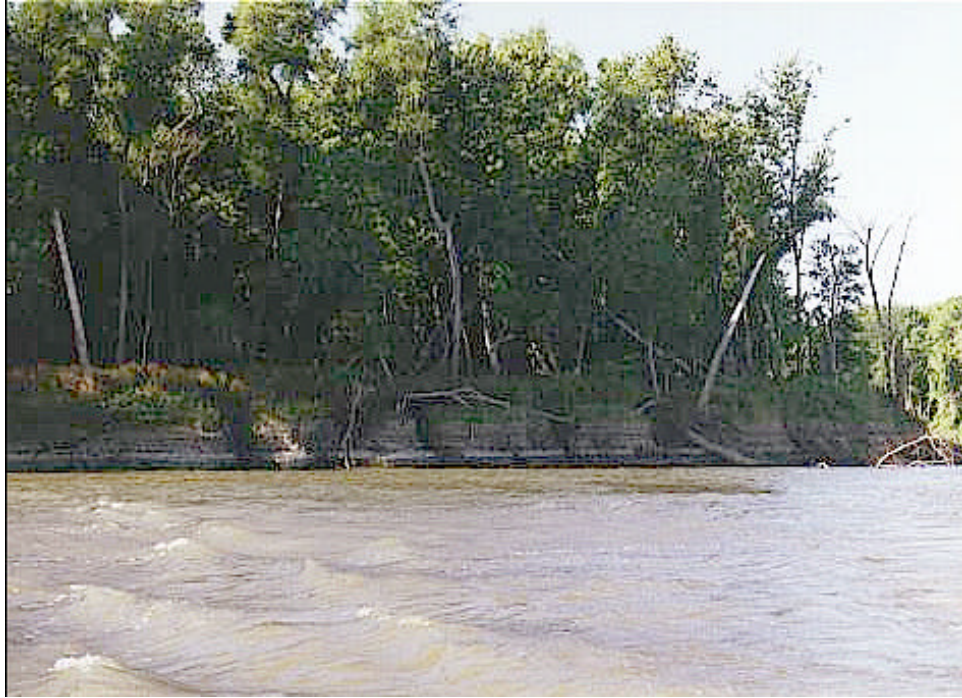
This observation site is near the tip of Maple Island, 2.7 miles downstream from Lock & Dam No. 26, and exhibits evidence of typical bank retreat caused by overland

**Photo 7-89 A side view of Observation Site at RM 200.2 RDB**

drainage. Bank-line incisions (gullies) cut by overland drainage and seepage can be seen in Photo 7-89. Photo 7-90 shows a close-up view of the scarp, which exhibits many features, including slaking, gully formation, vertical cracking, flood-flow related erosional oversteepening and recessional slumping, and piping and collapse. The bank soil was primarily silt and clay.

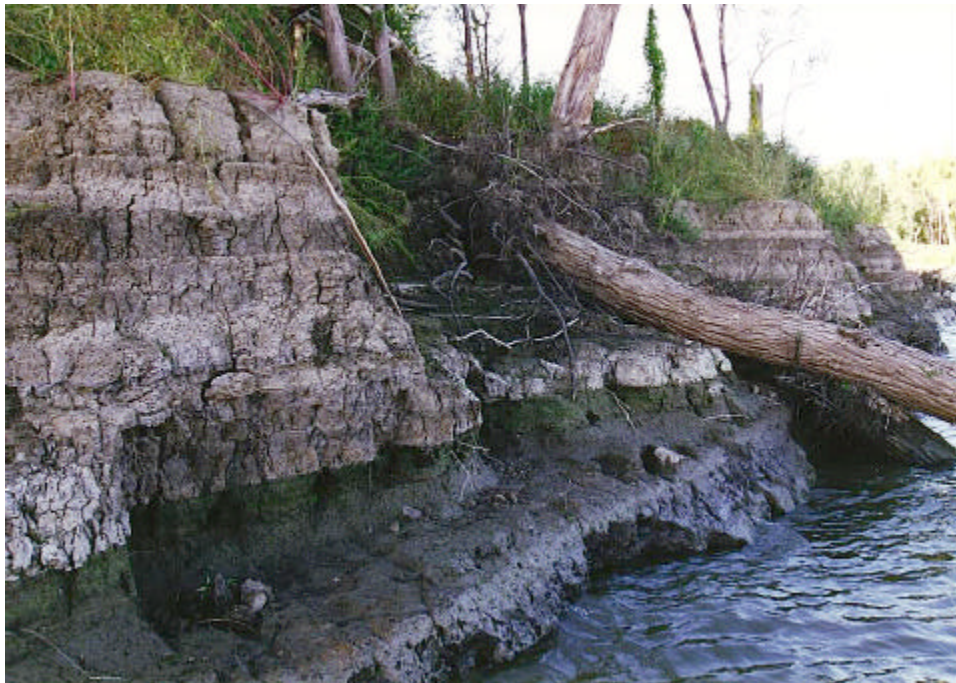
**Photo 7-90 A close-up view of Observation Site at RM 200.2 RDB**

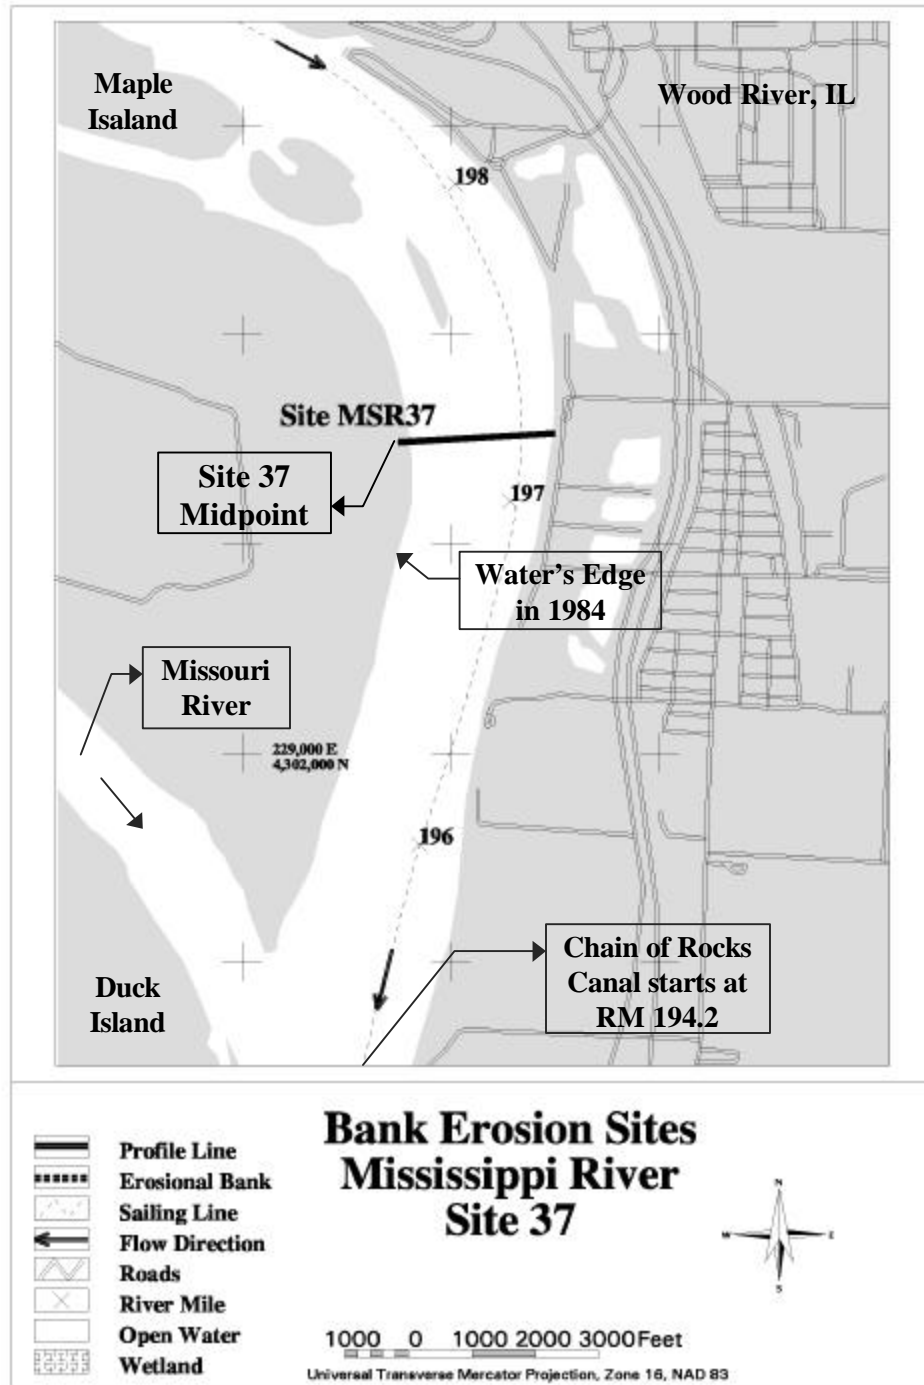
Figure 7-120 A map showing Mississippi River Site 37

This right-bank site on the inside of a sharp bend, shown in figure 7-120, is located less than 3 miles upstream from the Missouri River confluence at RM 195. Bank retreat since 1984 is evident in figure 7-120. Photos 7-91 and 7-92 show upstream and close-up views of the site, respectively. The bank section taken is shown in figure 7-121. The river cross section in figure 7-121 shows topography representative of the sharp bend along the site. The bank soils are primarily silt. The site is far from the thalweg sailing line. There is a barge-mooring site immediately downstream from the erosion site. There are several scarps within the bank. The levee along Mobile Island was overtopped during the Great Flood of '93, and this site is located where a breached portion of the levee was being repaired.

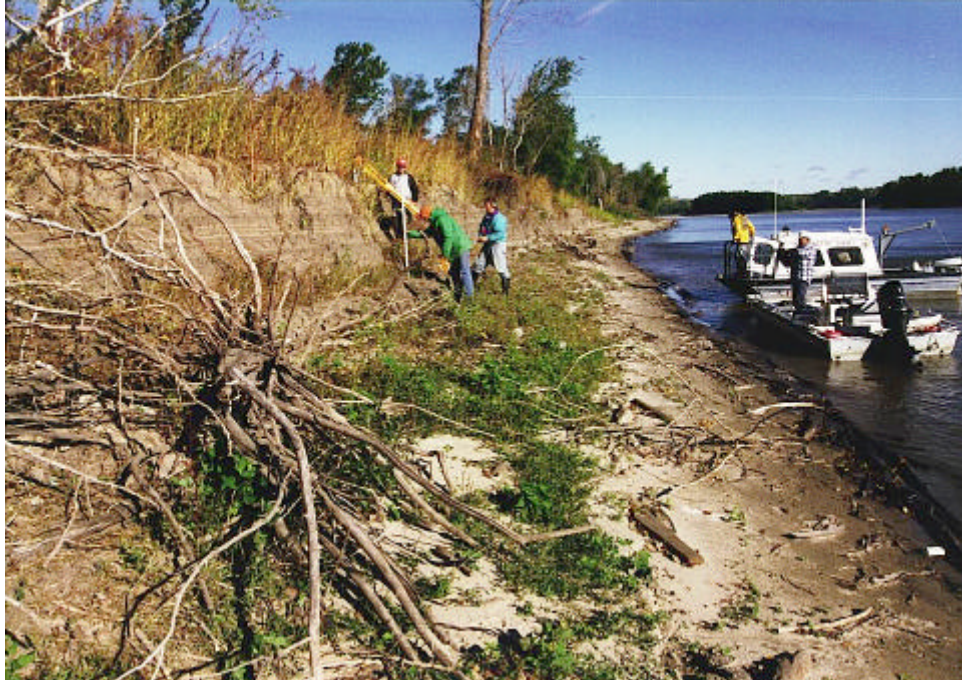
As at Site 36, causative factors for bank retreat at this site include flood-flow erosion and recessional failures, piping and collapse, slaking, overland flows, and wave and rework transport of failed soils and recently deposited sediments in bench areas. Due to nearby fleeting activities, more extensive wave erosion occurs at this site. Type C best characterizes Site 37.

**Photo 7-91 An upstream view of Site 37 midpoint**

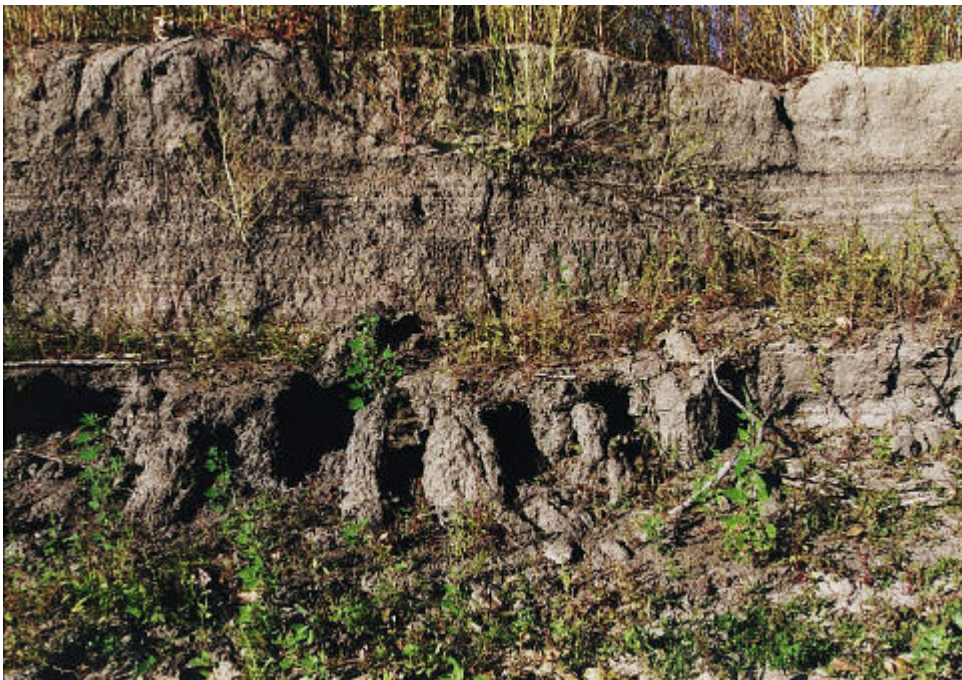
**Photo 7-92 A close-up view of Site 37 midpoint**

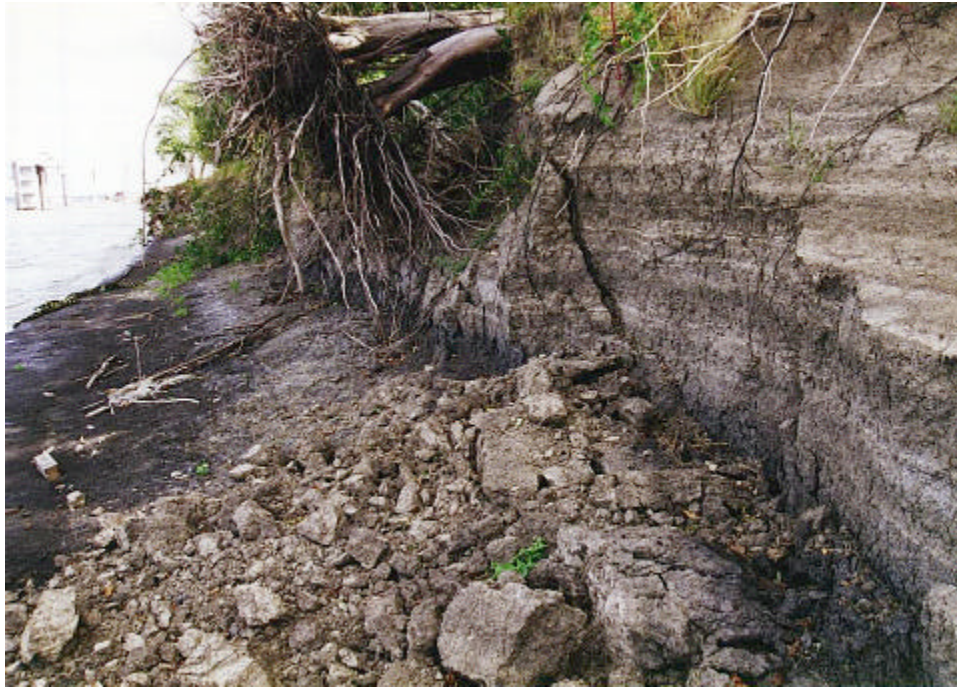
This left-bank observation site is located immediately upstream from the mouth of the Oahokia Creek diversion channel, and directly opposite the confluence of the Missouri River. The scarp exposes silty clay and clayey silt layers and is about 4 ft to 6 ft high. Historical deposits can be seen clearly in Photos 7-93 and 7-94. A dark-color native soil at the bottom of the scarp, as well as vertical cracks and fallen soil blocks, can be seen in these photos. At this site, a simple field experiment was conducted to demonstrate how fast a block of failed bank soil would disintegrate in water. A block of soil, about 4 in. high, 4 in. wide, and 8 in. long, was carefully placed in water, as shown in Photo 7-95. Only the bottom portion, about 1 in., was wet initially; however, the block disintegrated as soon as it was wetted. The process of this block disintegration is illustrated by Photos 7-96 through 7-98. Within 3 minutes, the entire block disintegrated. These photos are extremely important in describing the unique characteristics of failed soil blocks and peds which cannot resist wetting and slaking. Wetting destroys capillary

**Photo 7-93 An upstream view of Observation Site at RM 195.1 LDB**

action in fissures between peds, and the block disintegrates into individual fissure-defined pieces (peds). Any banks composed of unsaturated soils would be susceptible to wet/dry slaking. This observation site was eroded severely during the Great Flood of '93 and possibly during the flood of 1994 and the flood of 1995. The site demonstrates typical characteristics of bench area rework and transport described earlier. This erosion site can be classified as Type A.

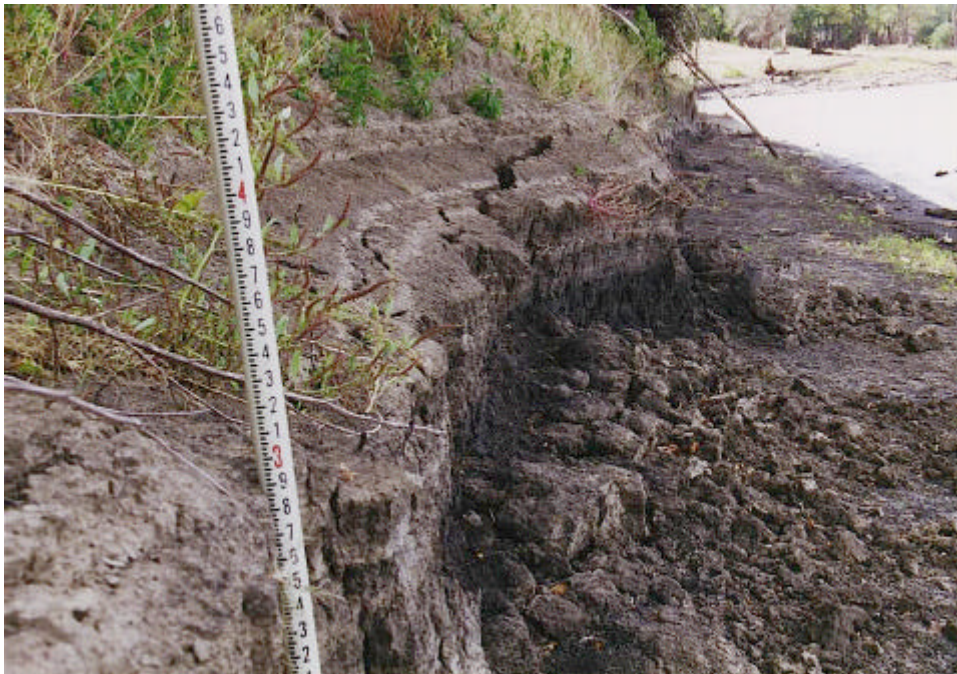
**Photo 7-94 A downstream view of Observation Site at RM 195.1 LDB**

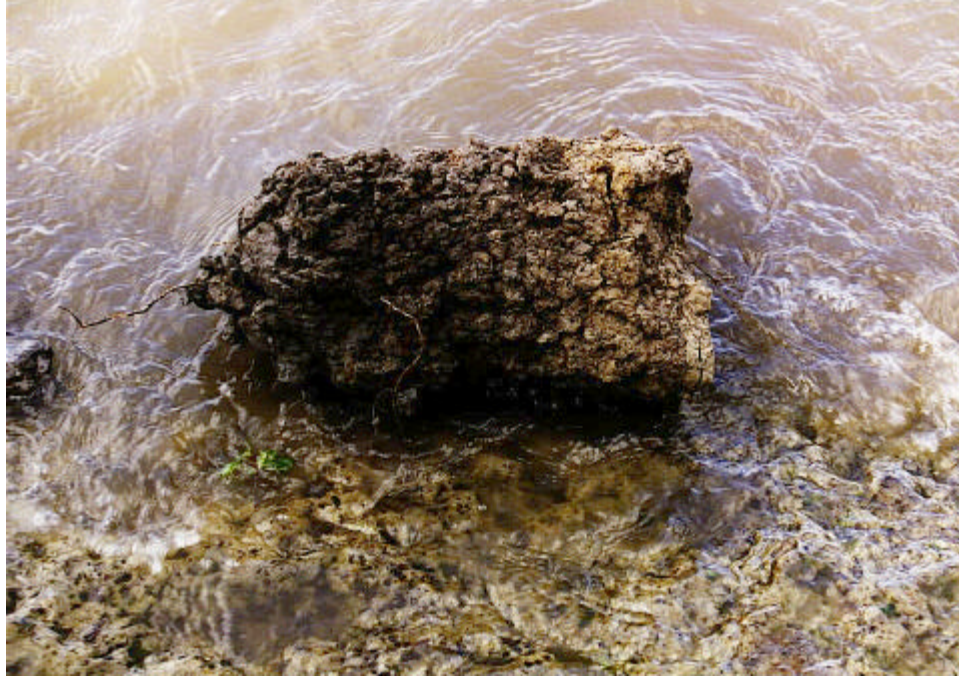
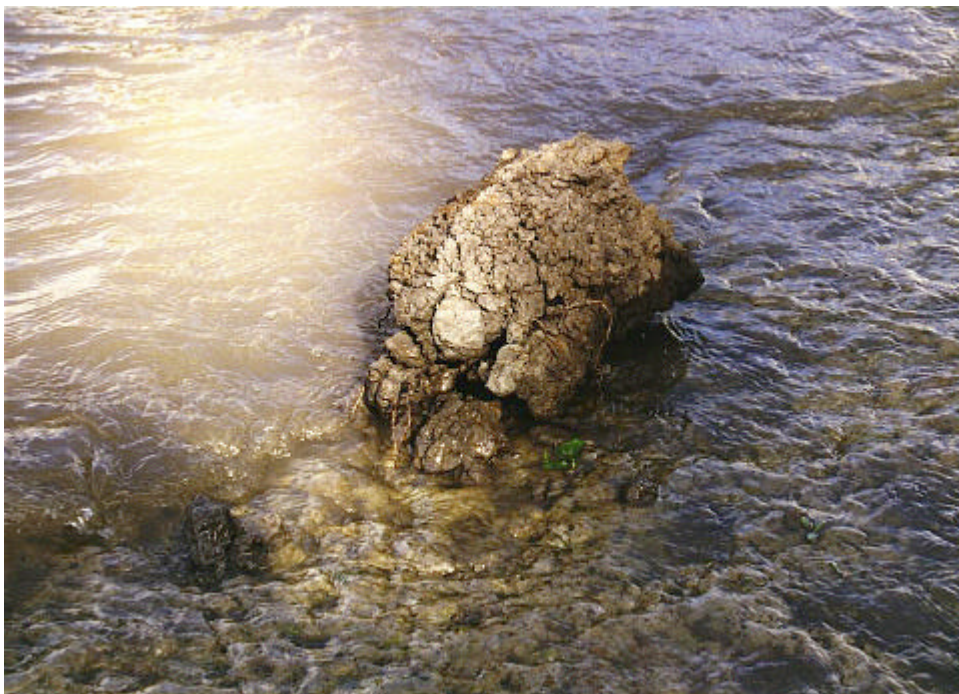
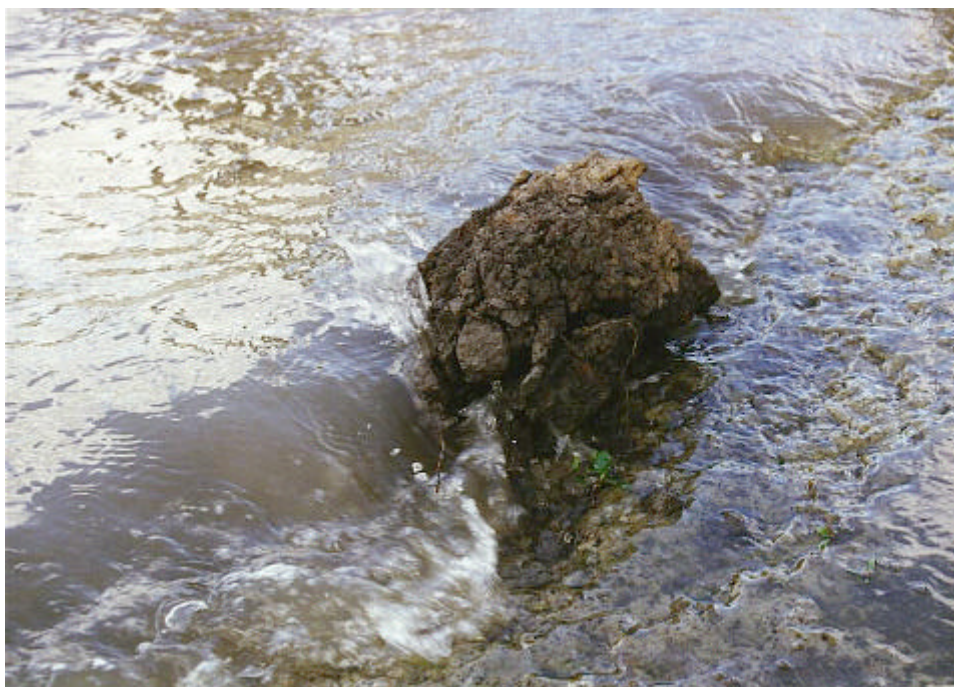
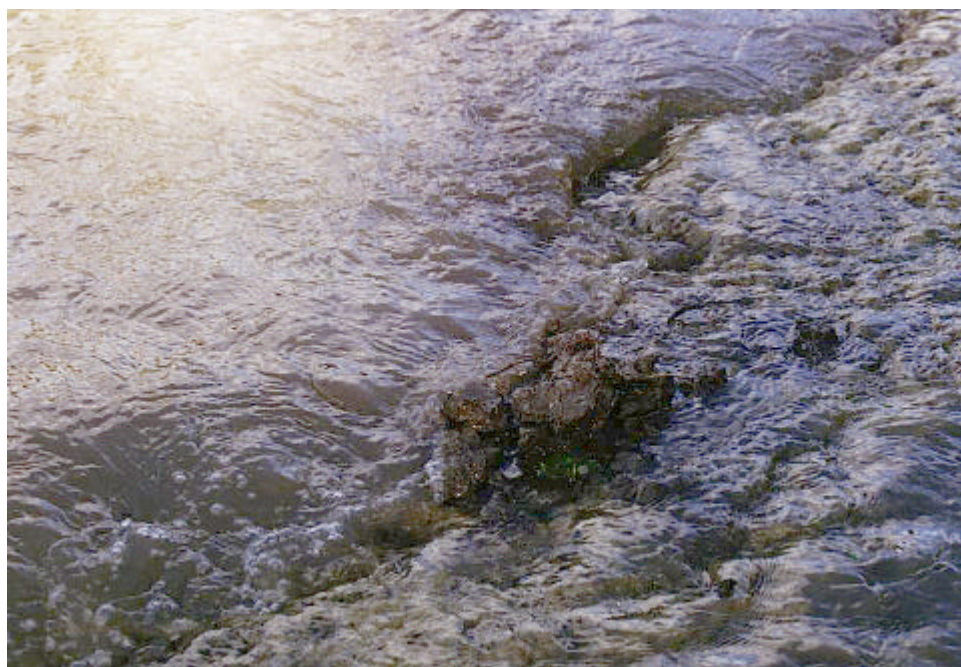
**Photo 7-95 A block of failed bank soil placed in water ( $t = 0$ ) -- Observation Site at RM 195.1 LDB**

**Photo 7-96 A block of failed bank soil placed in water ( $t = 1$  min.) -- Observation Site at RM 195.1 LDB**

**Photo 7-97 A block of failed bank soil placed in water (t = 2 min.) --  
Observation Site at RM 195.1 LDB**

**Photo 7-98 A block of failed bank soil placed in water (t = 3 min.) --  
Observation Site at RM 195.1 LDB**

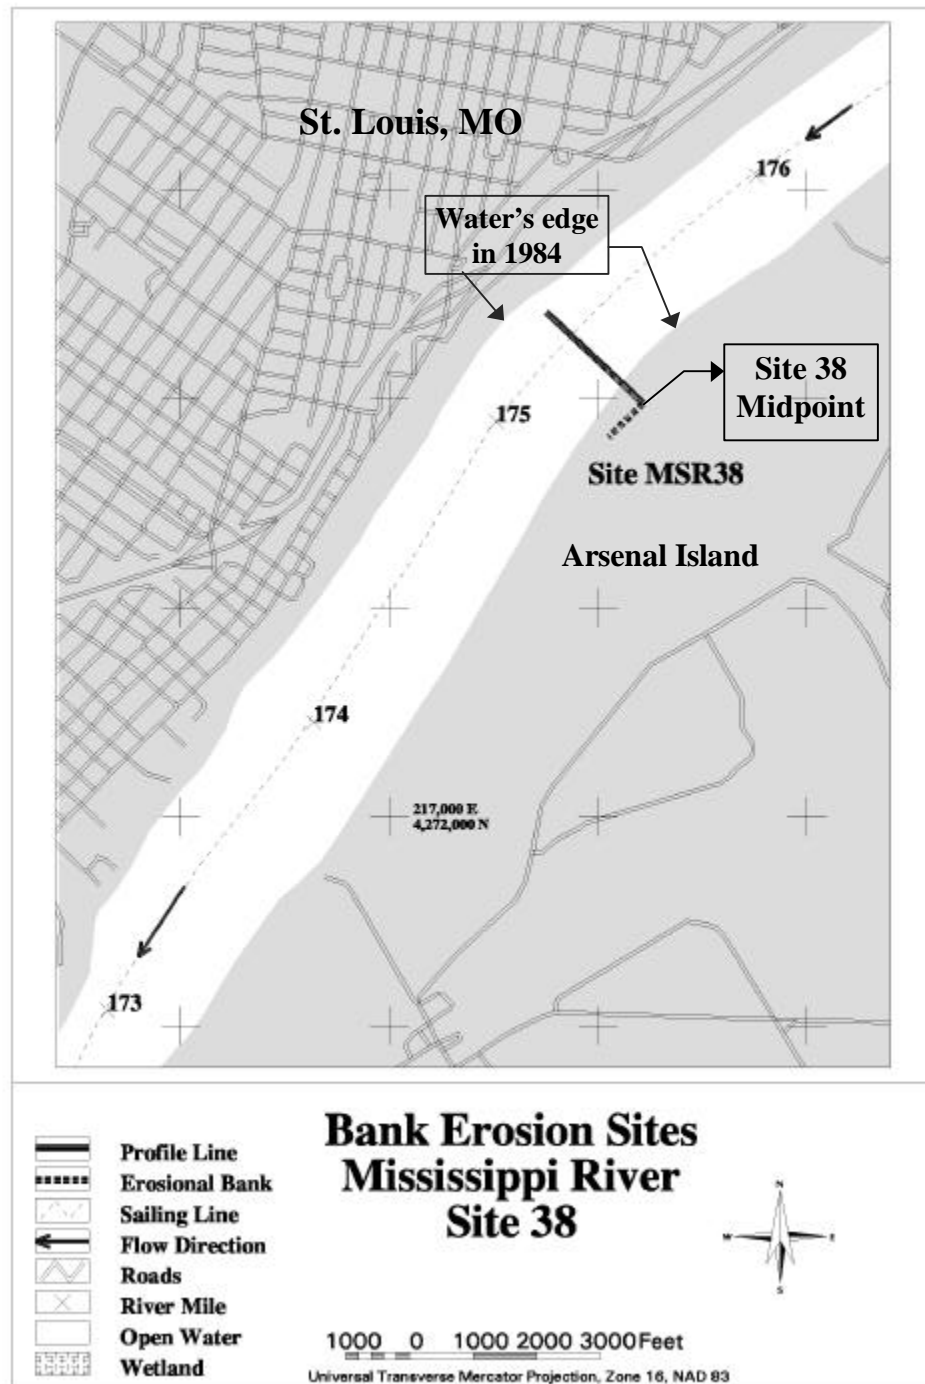
Figure 7-122 A map showing Mississippi River Site 38

This left-bank site, shown in figure 7-122, is located within a busy fleeting area along a straight reach near St. Louis, Missouri. As can be seen in figure 7-122, the bank appears to have retreated considerably since the current navigation chart, based on the 1984 COE aerial survey, was published in 1989. Photos 7-99 and 7-100 show upstream and close-up views of the site, respectively. Photo 7-101 shows an upstream view of the bench, and Photo 7-102 shows a close-up view of wave attack on the lower bank which consists of recently deposited sand. Only one bank section was taken at this severely eroded bank site, which is shown in figure 7-123. The bank soils are primarily MST and FS. There were three distinct scarps with extensive piping features, as shown in figure 7-123. At the top of the bank is a farm field covered by two large sand dunes, 2 to 3 ft high and about 200 ft wide. The first row of dunes was located along the edge of the bank, and the second was located about 1,000 ft from the bank line. Both dunes were oriented parallel to the bank line. This silty sand deposition and dune formation is believed to have been produced by the Great Flood of '93 and subsequent floods of 1994 and/or 1995. Fine

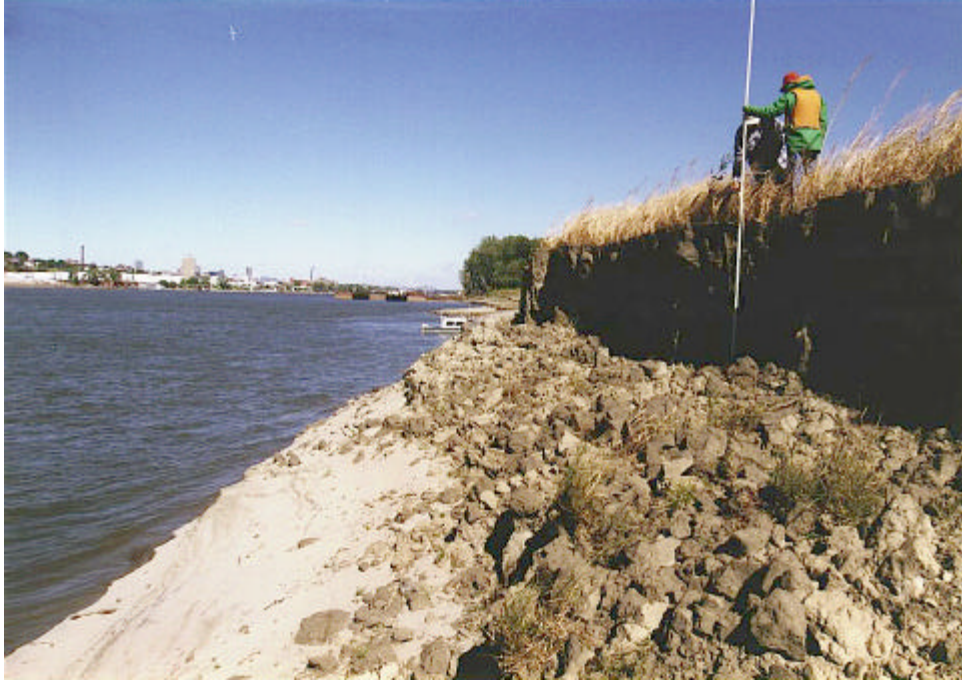
**Photo 7-99 An upstream view of Site 38 midpoint**

Causative factors for bank retreat at this site include flood-flow erosion and recession and piping failures, slaking, wave and rework-transport of failed soil peds and recently deposited silty fine sand, and aeolian deflation. Barge fleeting-related wave erosion occurs within the bench area at this site. A combination of bank Types A, B, and C describes Site 38.

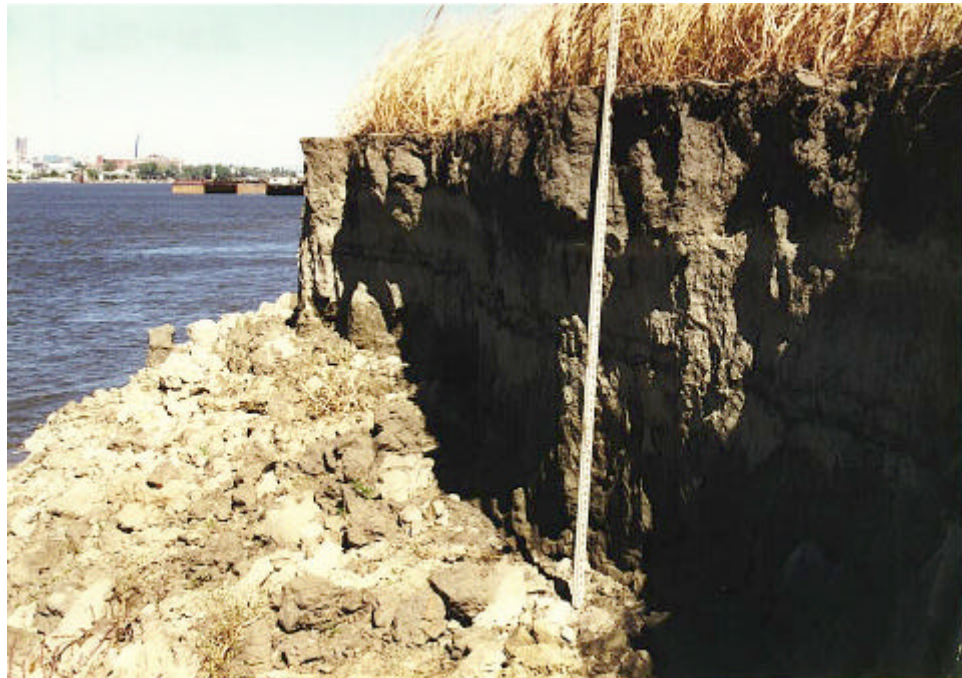
**Photo 7-100 A close-up view of Site 38 midpoint**

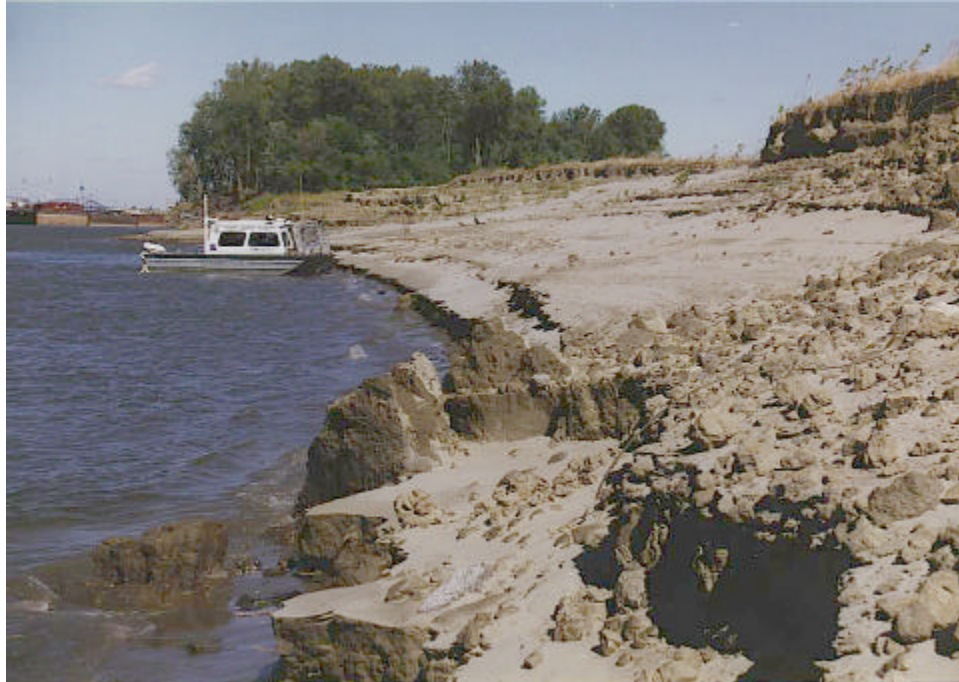
**Photo 7-101 An upstream view of bench of Site 38 midpoint**

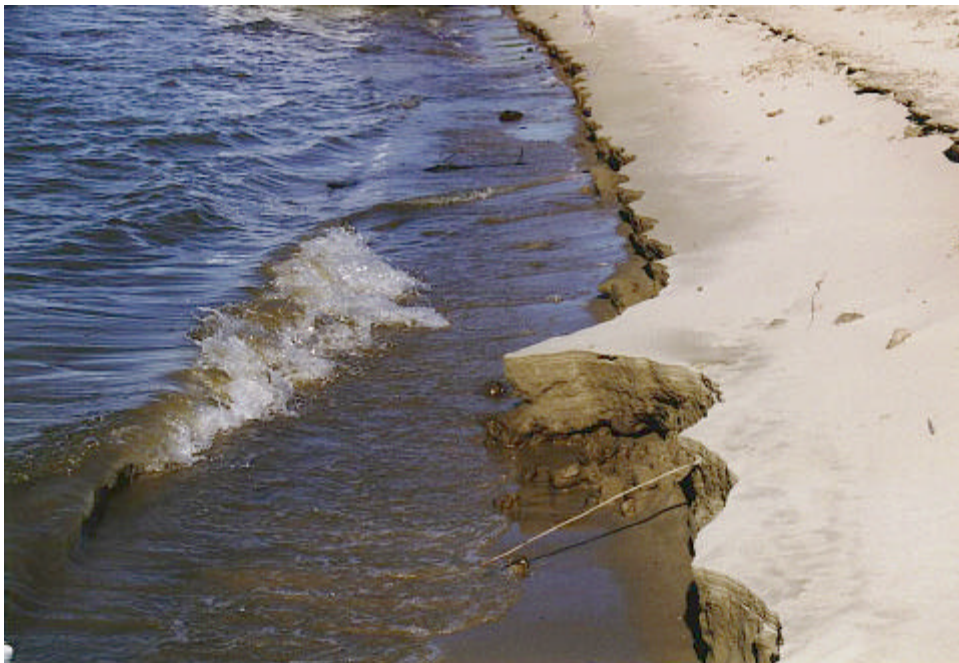
**Photo 7-102 A close-up view of wave erosion at Site 38 midpoint**

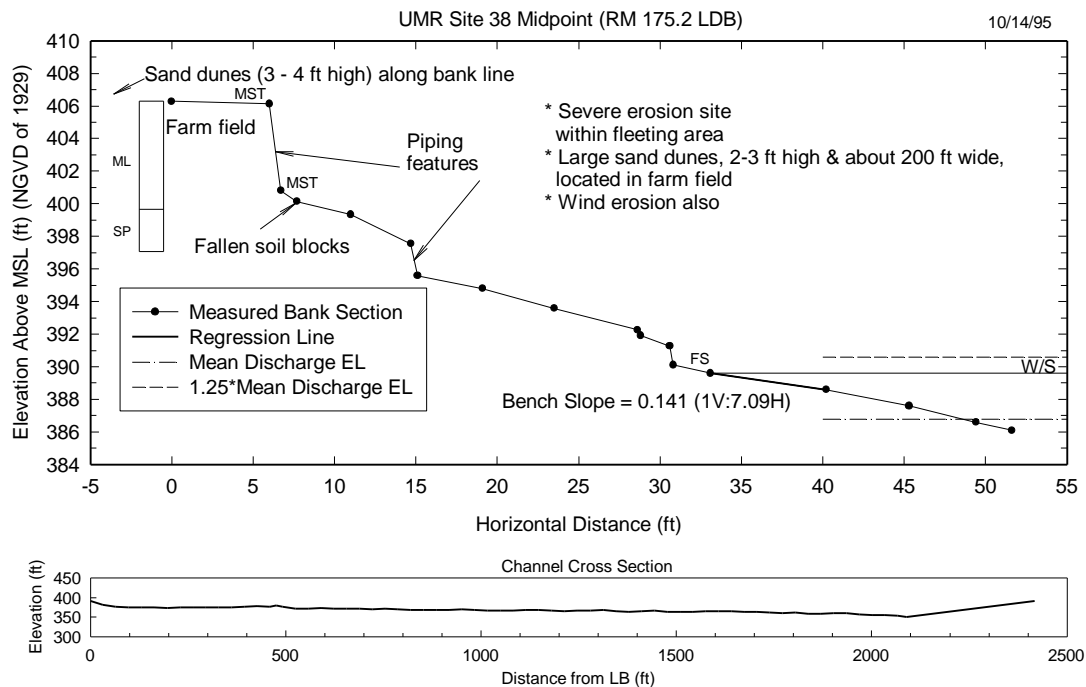
**Figure 7-123 Bank section and channel cross section measured at Site 38 midpoint**

sand was observed blown by strong winds. Numerous failed soil blocks were observed on the bank below the head scarp, as indicated in figure 7-123.

Site 38 is located on what may be a deeply buried late Holocene surface. Recent historical deposits are extremely thick at this site and native soils were not observed. The thickly bedded historical silt and very fine sand laminae extend to about 6.6 ft, below which lies well-sorted, fine to medium sand which may be dredged spoil. Other observations at this location show what appears to be a recent (1993, 1994, and/or 1995) coarse-grained flood deposit which contained buried leaf litter.

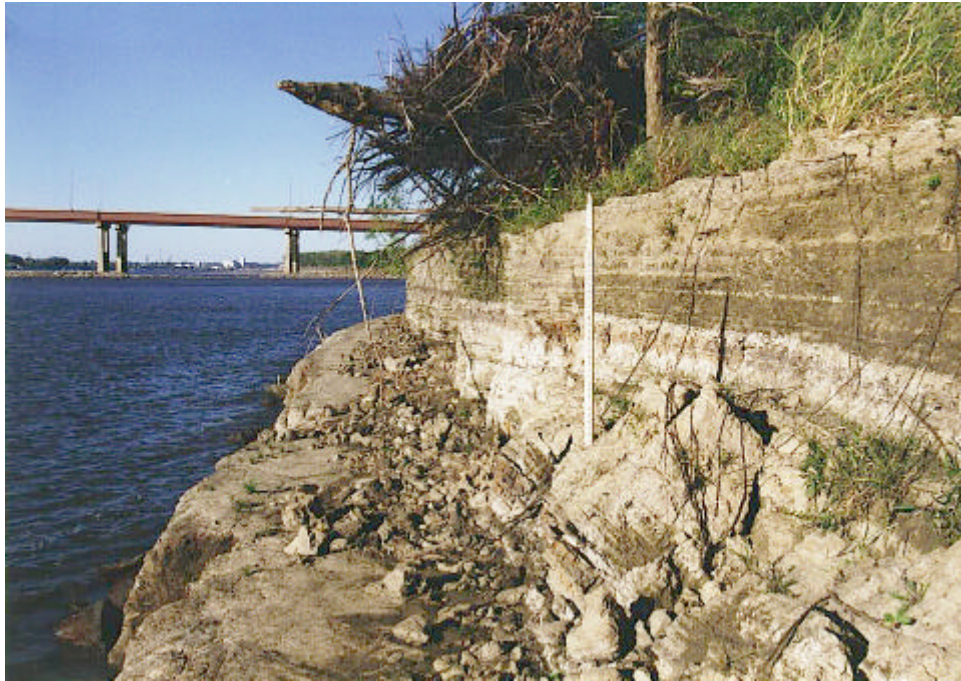
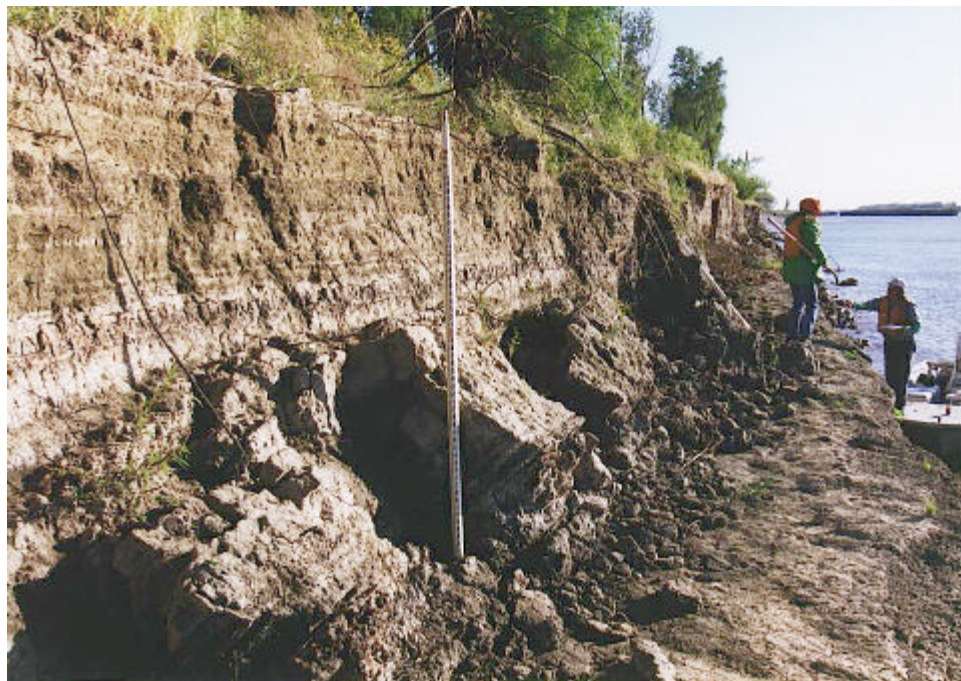
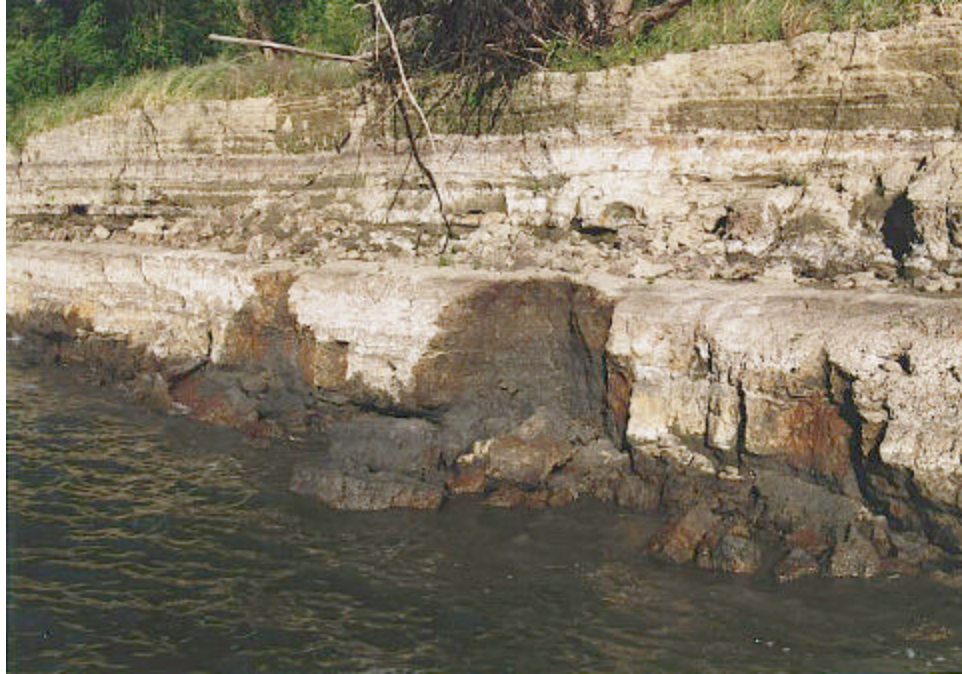
**Photo 7-103 An upstream view of Observation Site at RM 168.5 LDB**

**Photo 7-104 A downstream view of Observation Site at RM 168.5 LDB**

**Photo 7-105 A close-up view of Observation Site at RM 168.5 LDB**

filled flow-training structure. As shown in Photos 7-103 through 7-105, multiple layers of historical deposits consisting of silty clay and clayey silt are exposed within each scarp. There was a sand lens, about 3-in. thick at the bottom of each scarp. These lenses are shown in Photo 7-106. This site is characterized by Type B. It should be noted that many bank-erosion sites within the open-water reach were located immediately downstream from rock-filled flow-training structures.

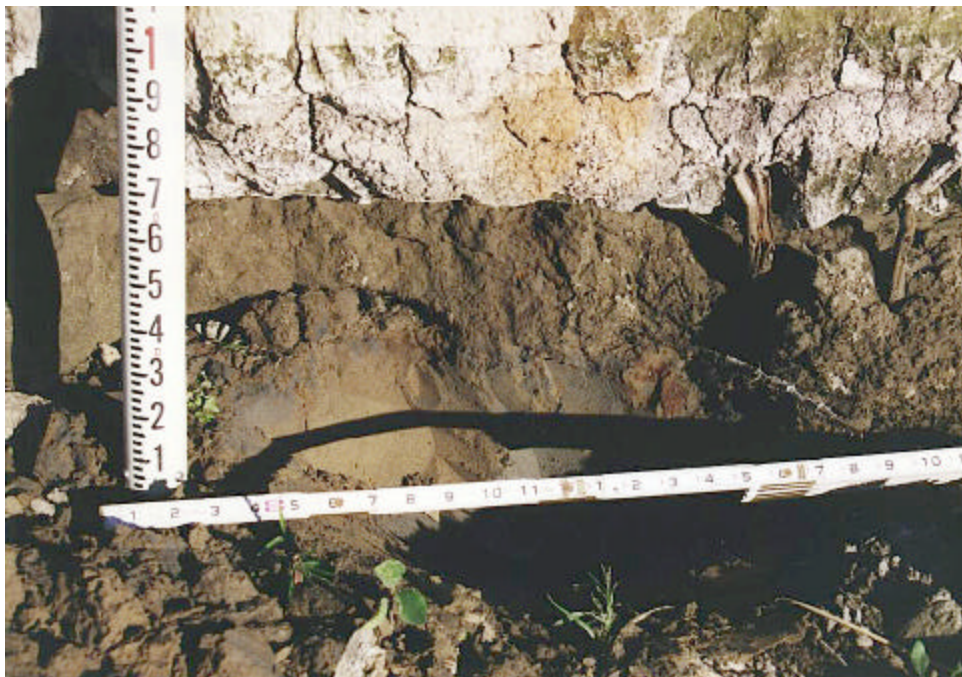
**Photo 7-106 Sand lens found at terrace of Observation Site at RM 168.5 LDB**

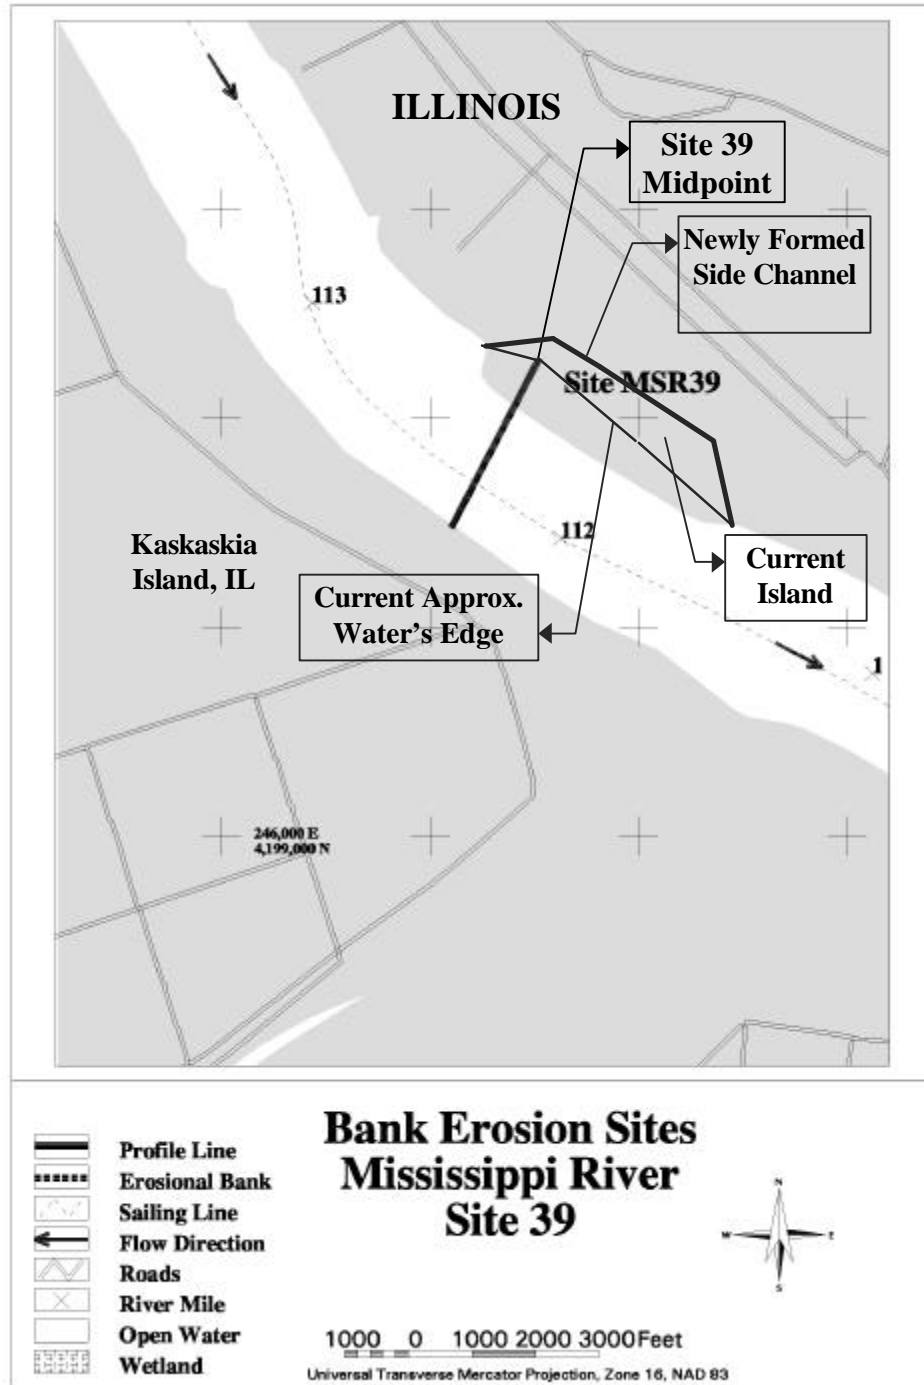
Figure 7-124 A map showing Mississippi River Site 39

This left-bank site, shown in figure 7-124, is located inside a bend on a small island. Photos 7-107 and 7-108 show upstream and downstream views of the site, respectively. Photo 7-109 shows eroded bank near the tip of the island and Photo 7-110 shows a close-up view of eroded bench. Although the site map does not show this bank to be on an island, erosion along the left bank at about RM 112.5 had formed a small island. The back channel of this island meets the MR at around RM 111.6. There are several large wing dams, and this erosion site is located between two wing dams. Around the upstream tip of the island, flow velocities toward the back channel were estimated to be about 8 ft/s. These flows are eroding the island. This erosion along the concave bank was initiated by the Great Flood of '93. The back channel apparently was eroded deeply during the flood, creating a large differential head between the main MR channel and the slough.

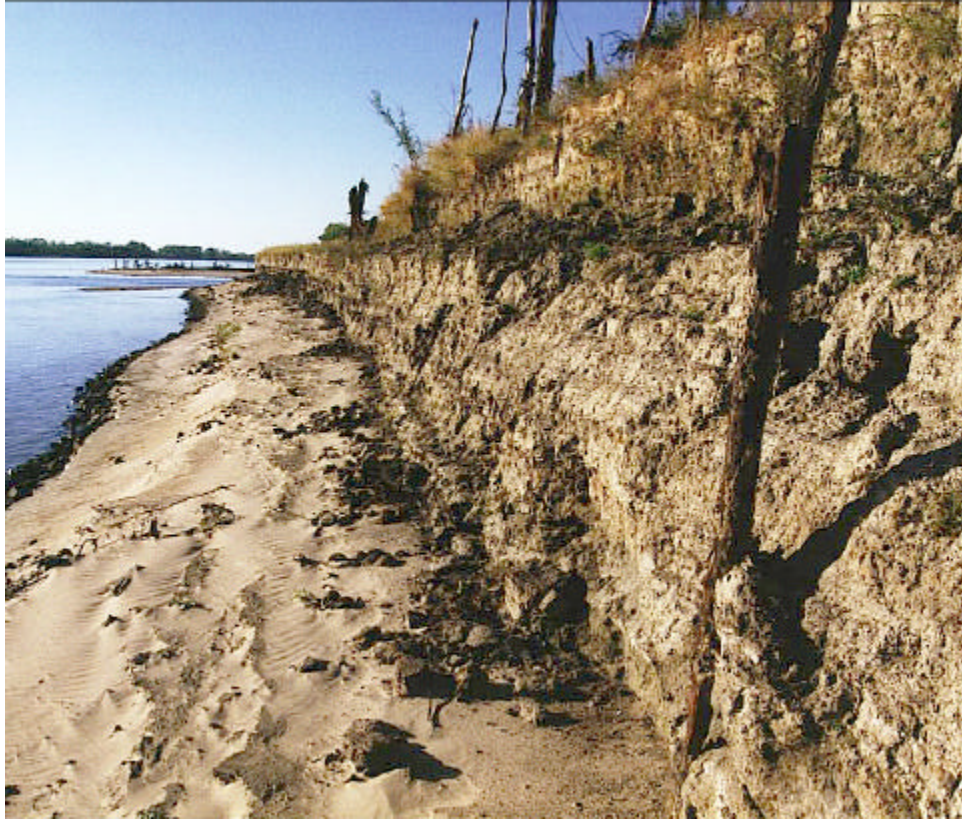
**Photo 7-107 An upstream view of Site 39 midpoint**

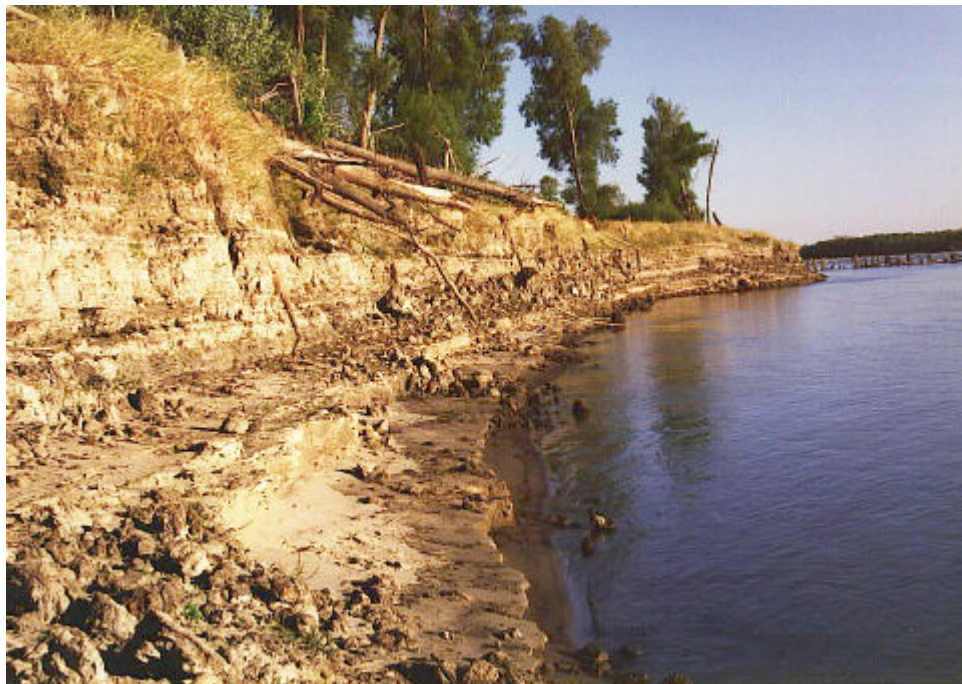
**Photo 7-108 A downstream view of Site 39 midpoint**

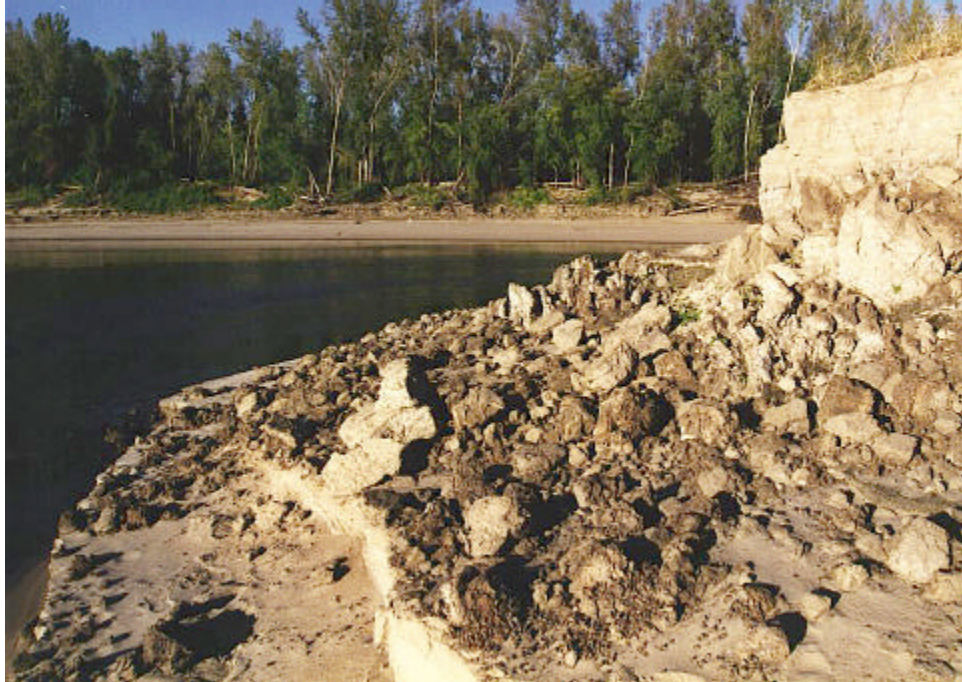
A wing dam and a large sand bar, located just upstream from the island tip, exacerbates island erosion by creating additional differential head where it diverts the MR flow toward the slough. The sand bar upstream of the island appeared to act as a dam to produce differential head. As shown in figure 7-125, multiple scarps with piping features were present with failed soil blocks. The total height of scarps was almost equal to the bank height, about 20 ft, and the bank soils are primarily medium silt (MST) and fine sand (FS). Subaqueous bed sediments consist of fine sand (FS).

**Photo 7-109 An upstream view of the tip of island at Site 39**
